# Logitech Webcam Pro 9000 USB Connection Replacement

Written By: Cory Davis

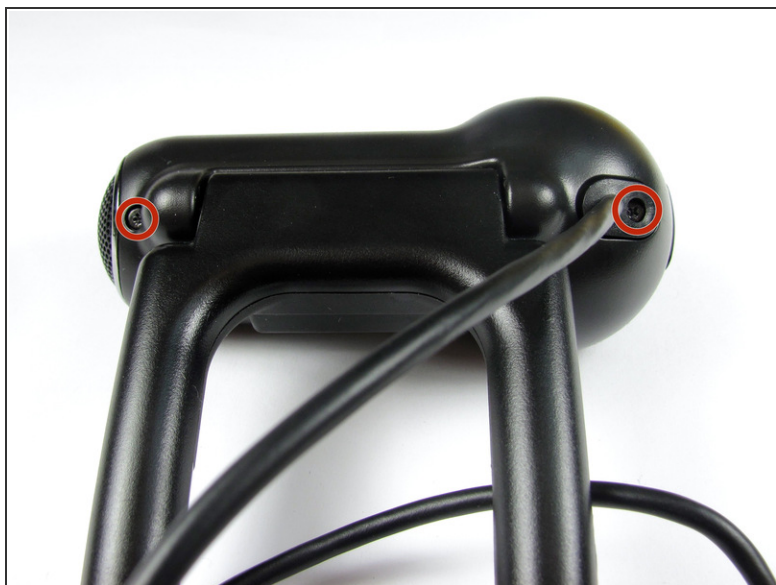
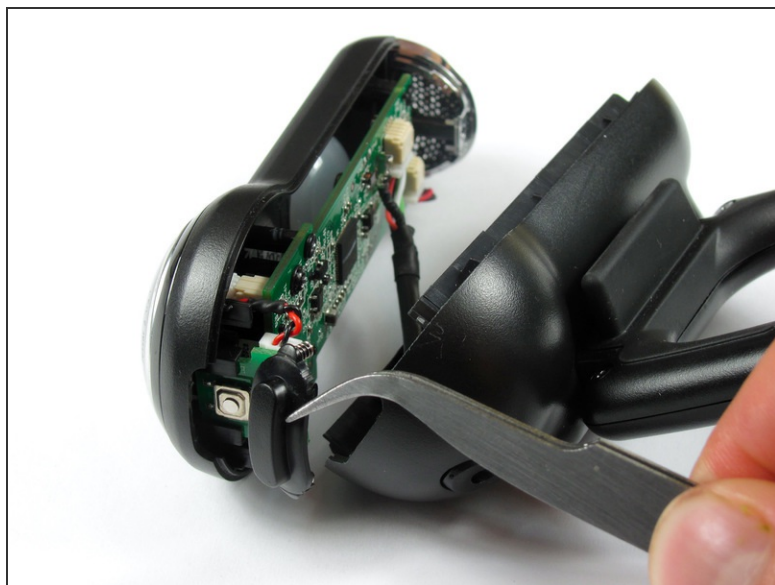
## Step 1 — Front and Back Cover

- Remove the two 8mm Phillips#0 screws on the back cover.

⚠ The motherboard is attaching the two covers together, so don't separate them entirely just yet.

ⓘ There is a button that loosens as the Phillips screws are removed. Don't be alarmed if it falls out.

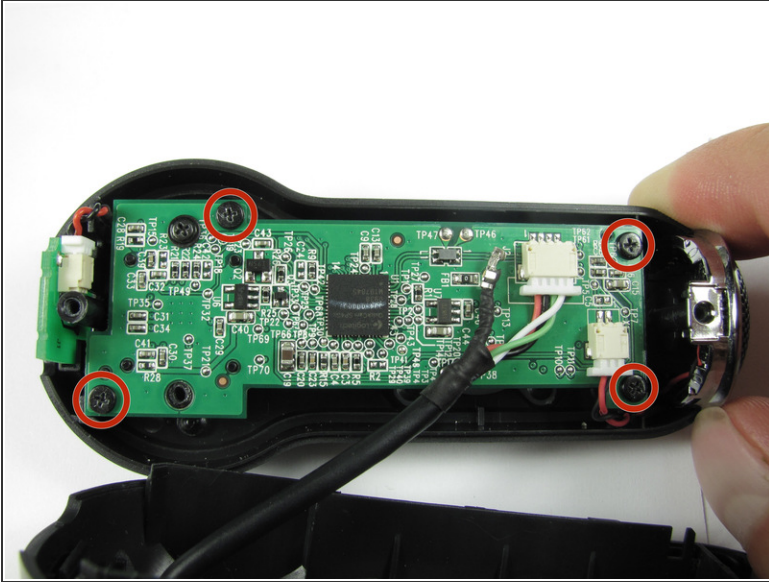
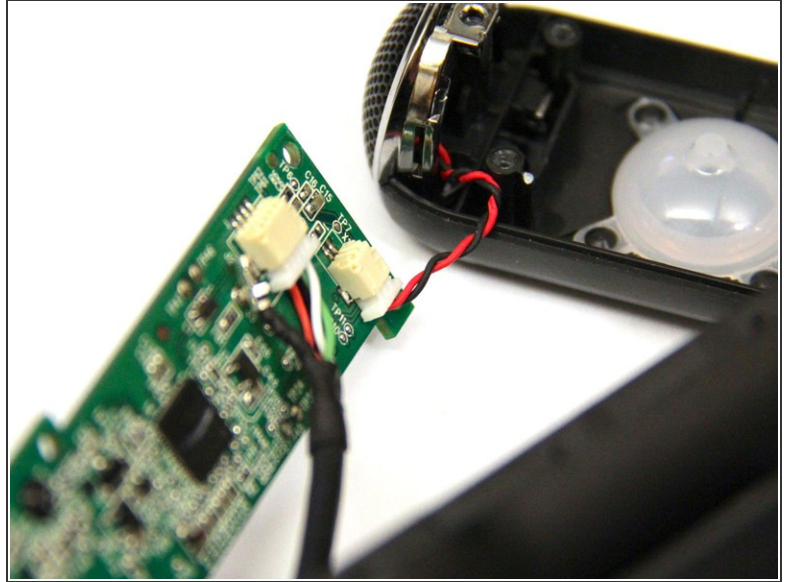
## Step 2

- Remove the four 6mm Phillips#0 screws connecting the motherboard and front cover.

⚠ **DO NOT** detach the wire connecting the motherboard to the front cover.

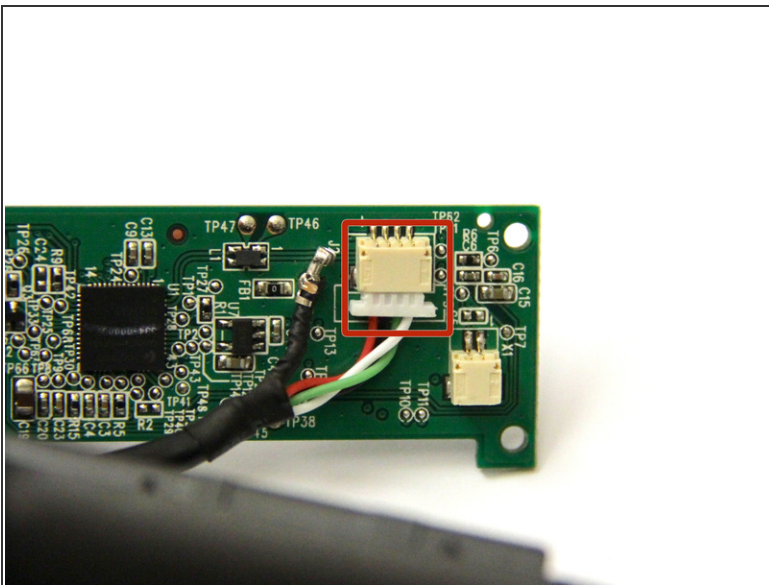
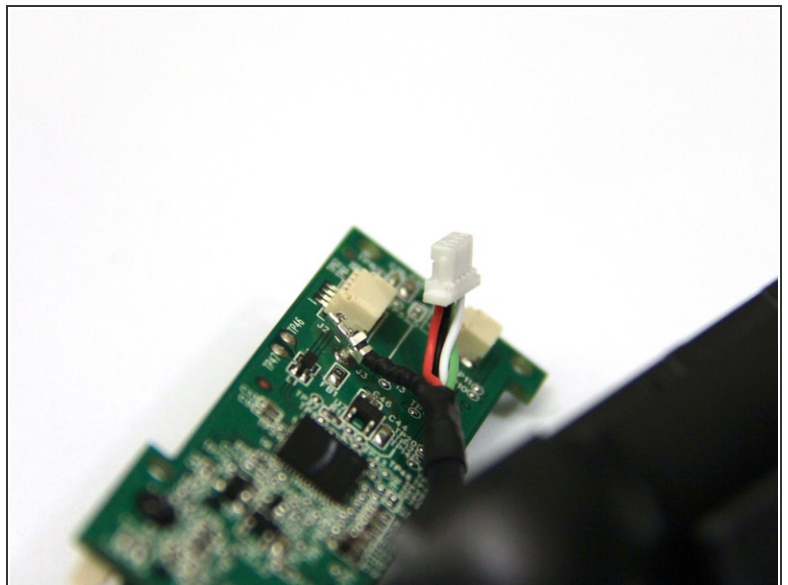
## Step 3 — USB Connection

- Grasp the white wire connector on the back of the motherboard to remove the USB cable.
- Wiggle the connector back and forth to remove it from the socket.

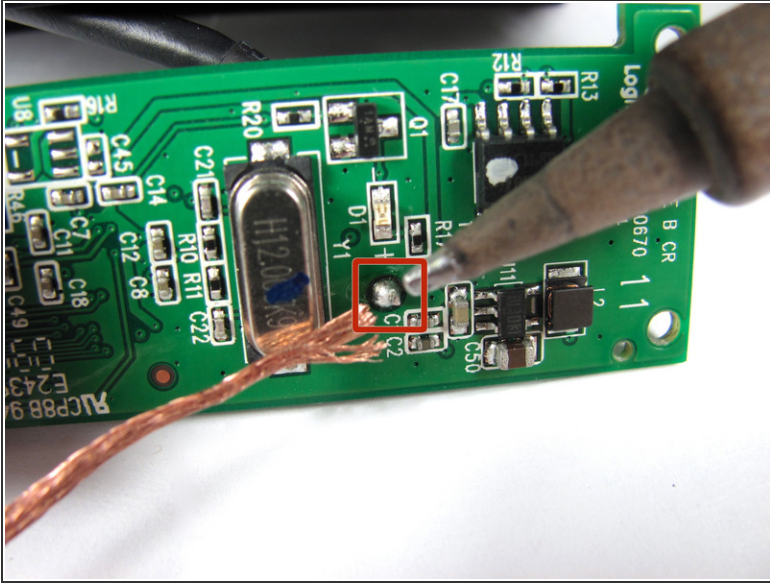
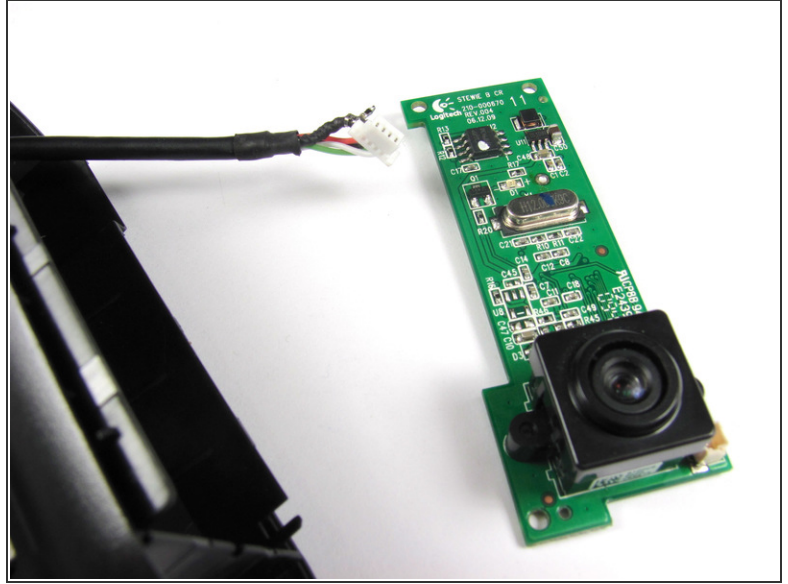
## Step 4

- Desolder the joint on the front of the motherboard to completely detach the USB cable.
